**Flood Control Project Maintenance
Levee Inspections**
LMA District Cover Sheet
Spring 2017 Levee Inspection Results

Reclamation District No. 0765 Glide

Spring 2017 Levee Inspection Results

Waterway			Bank	Unit Miles
Unit No. 01 Sacramento River			Right	1.72
	Spring (March - May)	Summer (June - August)	(September - November) Fall	Winter (December - February)
Unit Maintenance Rating (Fall Only)				
Date of Inspection	3/13/2017 - 3/13/2017			
DWR Inspector	Richard Willoughby			
Accompanied By	Everett Lovejoy RD 765

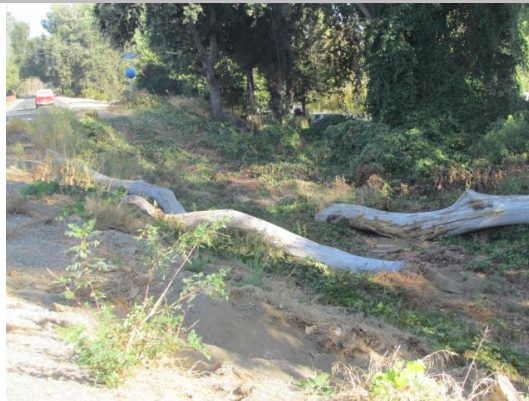
Photo 3 of 4 : SP_2017_RD0765_211_7_20170313_00009.jpg

LM Start	1.32	Rating **	U	Issue No.	7 (cont)
LM End	1.34	Issue Type +	Ma	Location *	WS

Looking at several tree branches on waterward slope and berm.(2015)

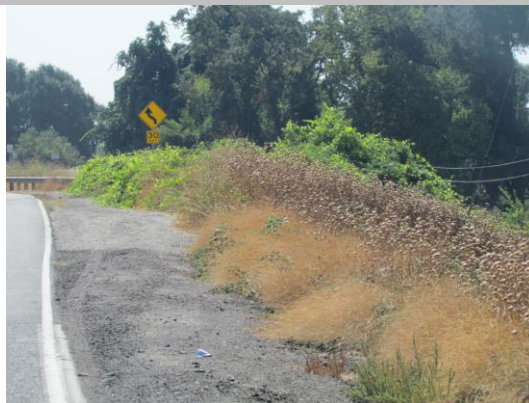
Photo 3 of 4 : SP_2017_RD0765_211_29_20170313_00027.jpg

LM Start	1.52	Rating **	U	Issue No.	29 (cont)	
LM End	1.62	Issue Type +	Ma	Location *	LS	
Category	Earthen Levee			GPS Latitude/Longitude		
				Start		End
Item	Vegetation			38.482665 °		38.481421 °
				-121.551036 °		-121.550207 °
DWR ID	DWR_RD0765_01_s_2012_29					
Comment Code						
V2 : Remove the wild growth other than native grasses from the levee slopes.						
Inspector Comment						
Dense berryvines and dense trees on landward slope has been in place for several inspection cycles.

Looking southwest at dense berry vines and other vegetation on landward slope. (Fall 2016)

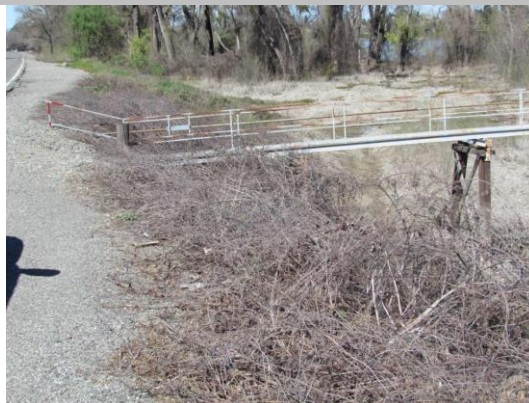
Photo 1 of 2 : SP_2017_RD0765_211_48_20170314_00093.jpg

LM Start	1.53	Rating **	U	Issue No.	48
LM End	1.56	Issue Type +	Ma	Location *	WS
Category	Earthen Levee			GPS Latitude/Longitude	
				Start	End
Item	Vegetation			38.482539 °	38.482144 °
				-121.550887 °	-121.550657 °
DWR ID	DWR_RD0765_01_f_2016_48				
Comment Code					
V2 : Remove the wild growth other than native grasses from the levee slopes.					
Inspector Comment					
Wildgrape vines on waterward slope are dead but should be removed from waterward slope.

Looking north at dead vines on waterward slope. (Spring 2017)

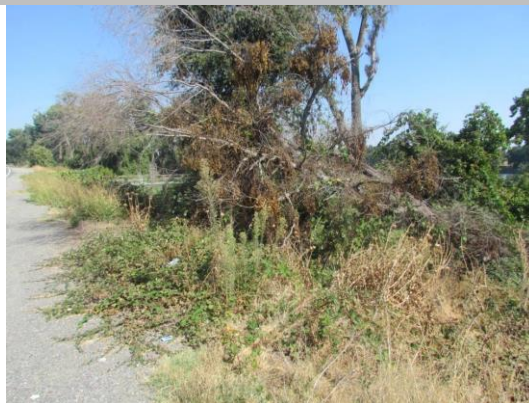
Photo 1 of 2 : SP_2017_RD0765_211_39_20170313_00035.jpg

LM Start	1.59	Rating **	U	Issue No.	39
LM End	1.59	Issue Type +	Ma	Location *	WS
Category	Earthen Levee			GPS Latitude/Longitude	
				Start	End
Item	Encroachments			38.481798 °	38.481798 °
				-121.550449 °	-121.550449 °
DWR ID	DWR_RD0765_01_f_2016_39				
Comment Code					
TR : Tree or limb					
Inspector Comment					
Downed tree on waterward slope.

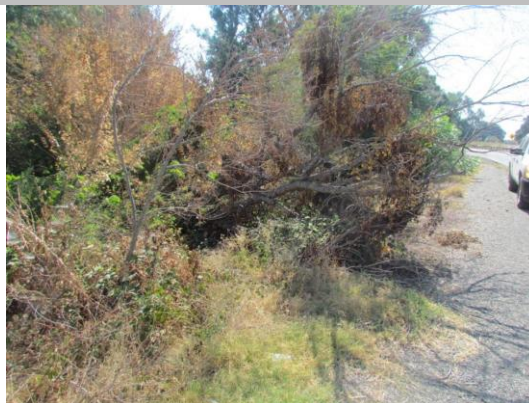
Photo 2 of 2 : SP_2017_RD0765_211_39_20170313_00036.jpg

LM Start	1.59	Rating **	U	Issue No.	39 (cont)	
LM End	1.59	Issue Type +	Ma	Location *	WS	
Category	Earthen Levee			GPS Latitude/Longitude		
				Start	End	
Item	Encroachments			38.481798 °	38.481798 °	
				-121.550449 °	-121.550449 °	
DWR ID	DWR_RD0765_01_f_2016_39					
Comment Code						
TR : Tree or limb						
Inspector Comment						
Downed tree on waterward slope.

Looking north at fallen tree on waterward slope.

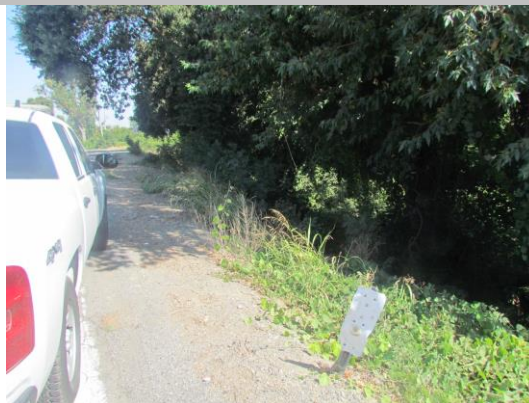
Photo 2 of 2 : SP_2017_RD0765_211_25_20170313_00023.jpg

LM Start	1.61	Rating **	U	Issue No.	25 (cont)	
LM End	1.72	Issue Type +	Ma	Location *	WS	
Category	Earthen Levee			GPS Latitude/Longitude		
				Start		End
Item	Vegetation			38.481501 °		38.480140 °
				-121.550239 °		-121.549426 °
DWR ID	DWR_RD0765_01_f_2016_25					
Comment Code						
V2 : Remove the wild growth other than native grasses from the levee slopes.						
Inspector Comment						
Dense vegetation on waterward slope.

Looking north at dense vegetation on waterward slope.
